Fraser Riverview LLC – Riverview Condominiums 76981 US Highway 40, Fraser, Colorado GPS 39.94059°N and -105.80331°W		
Sheet 1: Landscape Recommendations for Rain Garden Swale and Basin Version 29Jan20	Design: GSE Drafting: GSE Corps File # SPK-2019-00794	 Grand Environmental Services Working with the Environment TEXT 970-509-0199

Sheet 1: Landscape Recommendation Details for Bioretention Swale and Basin
Version 29Jan20

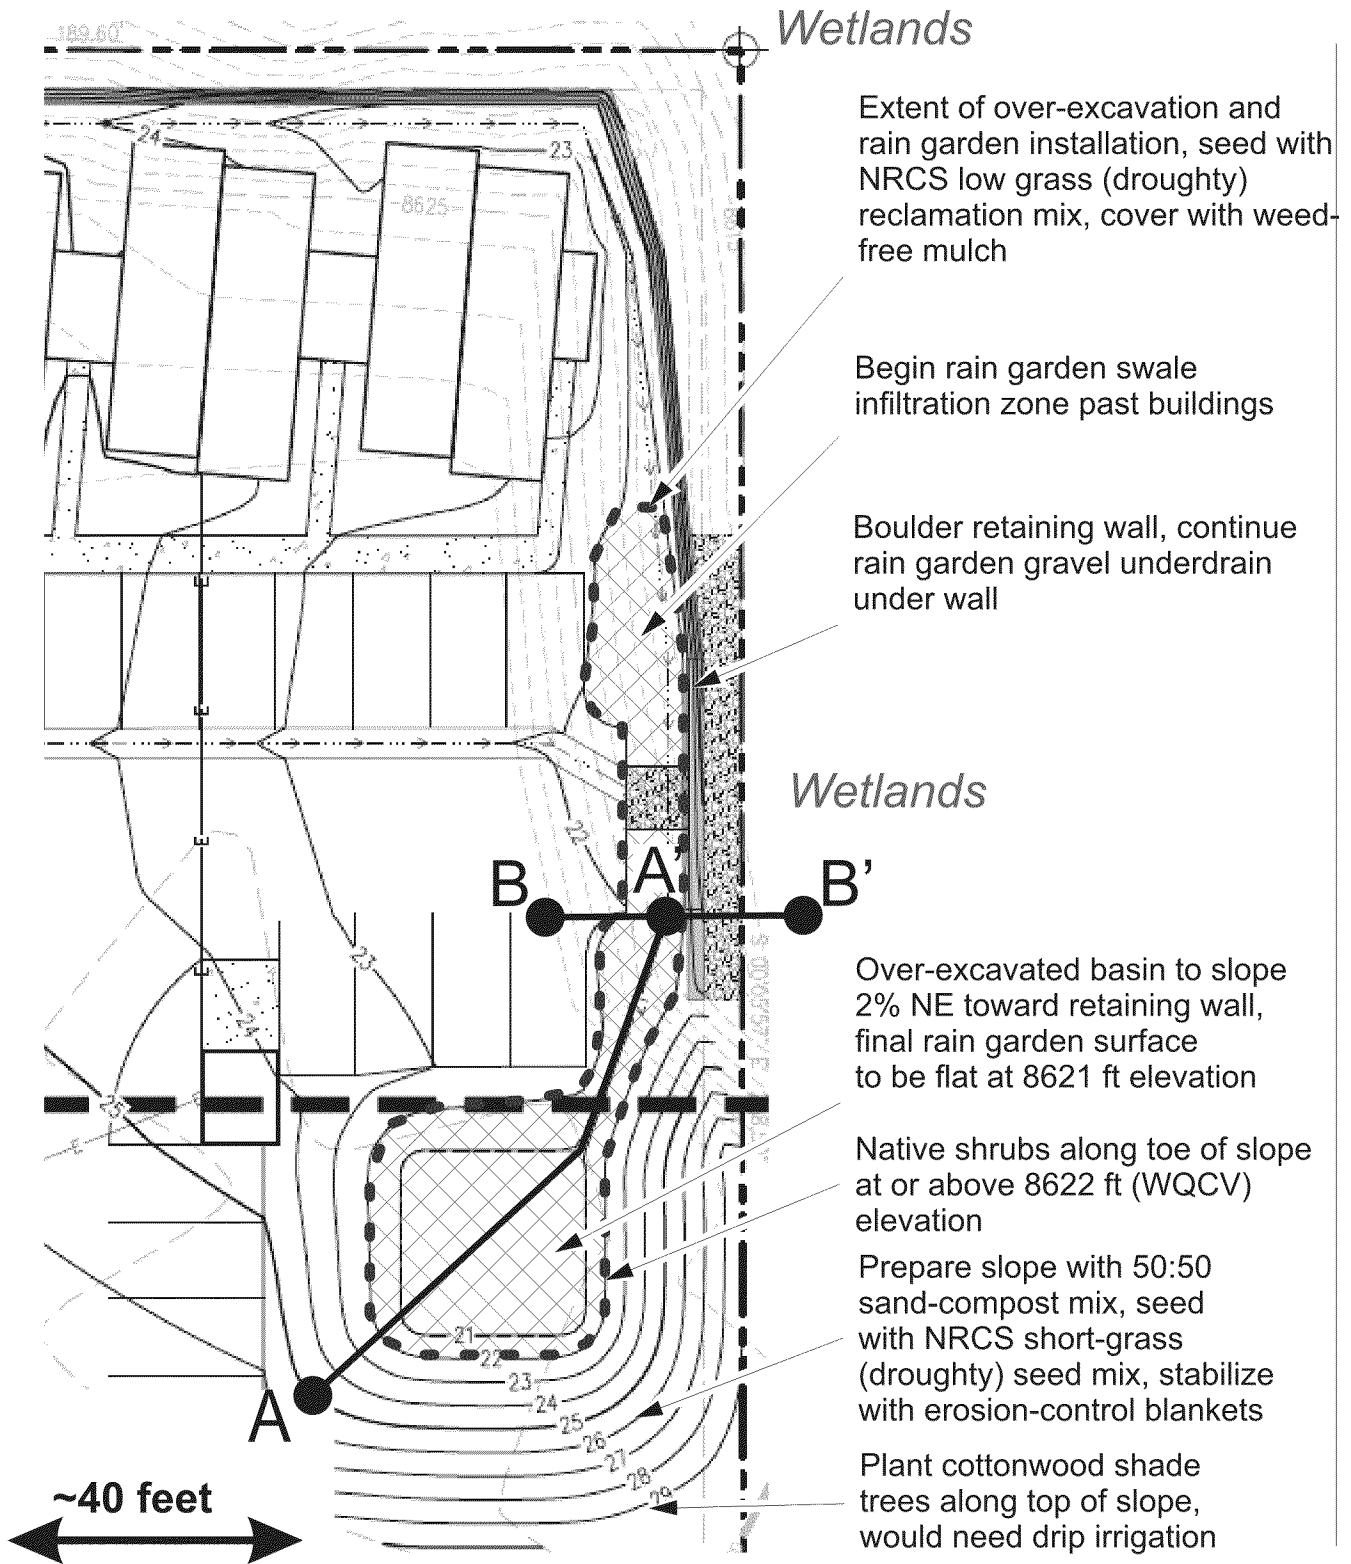
- A) Project avoids wetlands infiltrated stormwater expected to percolate into adjacent marsh to the east after bioretention
- B) Map base from JVA, elevations in feet
